Small-Scale Horizontal 1-Hour Fire Endurance Test 1

**International Fire Resistant Systems, Inc.
580 Irwin Street No.1
San Rafael, California 94901
Phone: 415-459-6488**

**WFCi Report #00050H.T1
(Wood and Embossed Tin Ceiling-Floor Assembly)**

Report Issued on May 24, 2000

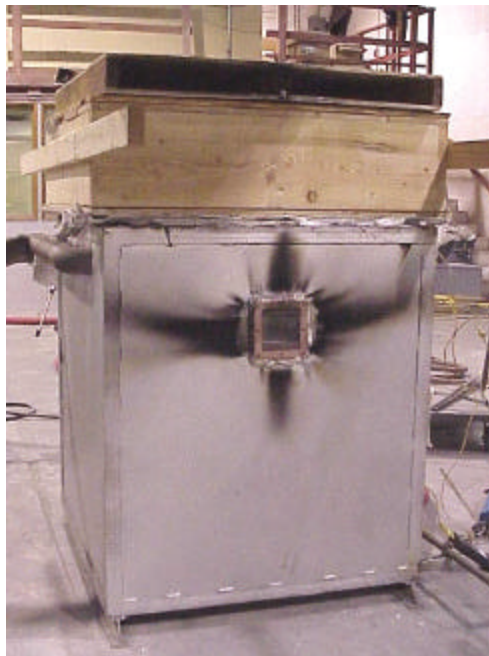
Figure 1. Small-scale Horizontal Exposure Furnace

This report documents the fire testing performed by Western Fire Center, Inc. (WFCi, *the laboratory*) for International Fire Resistant Systems, Inc., 580 Irwin Street, No. 1, San Rafael California, 94901 (*the customer*) on May 17, 2000. One small-scale horizontal fire endurance test was conducted on ceiling-floor assembly, which was constructed with embossed tin, ceiling joists and T & G pine flooring. The apparatus used in this test is described in detail within the Uniform Building Code (UBC) Standard 26-2, Small-scale Horizontal Exposure Furnace (Figure 1).

In this test, the specimen is placed on top of the furnace. The exposed surface is subjected to the time-temperature curve while temperature measurements are taken on the unexposed surface. Nine thermocouples are placed on the unexposed surface and then covered with a piece of calcium silicate board.

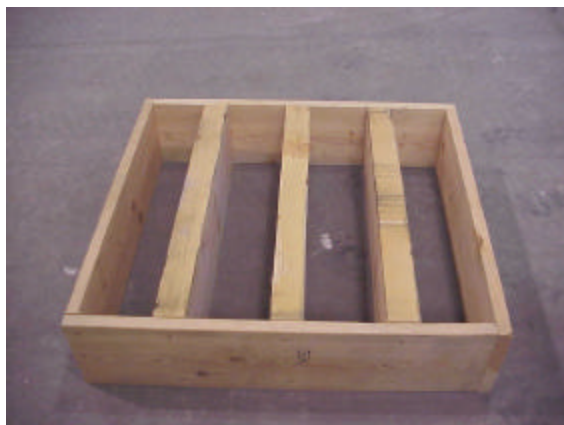
Figure 2. Construction of Test Assembly

- 4" x 12" ceiling joists (12" O.C.)
- 2" X 12" wood stud (Figure 2)
- Oak sheathing (1" x 6", diagonal, Figure 3)
- T & G pine floor finishing (Figure 4)
- 1" x 2" Douglas fir framing (Figure 5)
- Embossed tin ceiling (Figure 6)
- Firefree 88 intumescent paint (Ff₈₈, Figure 7)
- Envirotrol Primer (Figure 8)

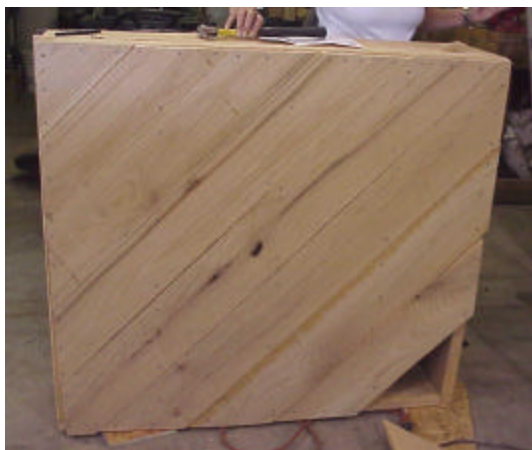
Figure 3. Oak Sheathing on One Side of the Wood Frame

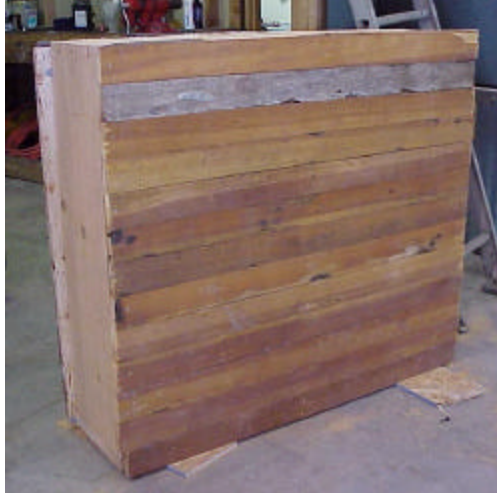
Figure 4. T & G Flooring as Assembly Unexposed Face

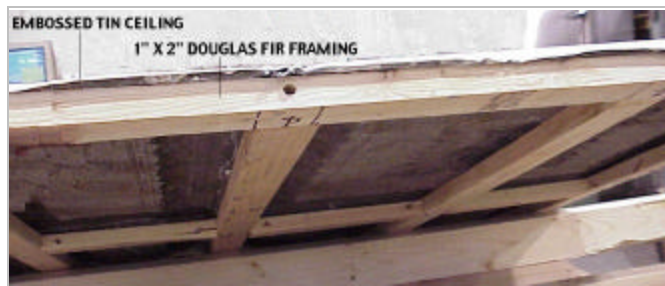
Figure 5. Tin Ceiling and Douglas Fir Frame

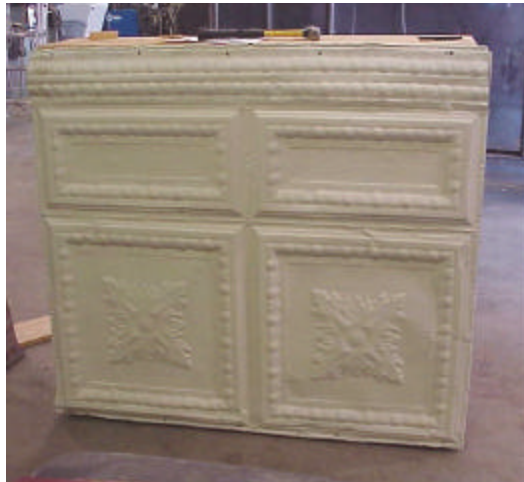
Figure 6. Ff₈₈ Coated Embossed Tin Ceiling as Assembly Exposed Face

The tin ceiling was sprayed coated with 40 dry mils of Ff₈₈ on May 3, 2000 after 10 dry mils of Envirotrol primer was air-dried. The test was conducted on May 17, 2000.

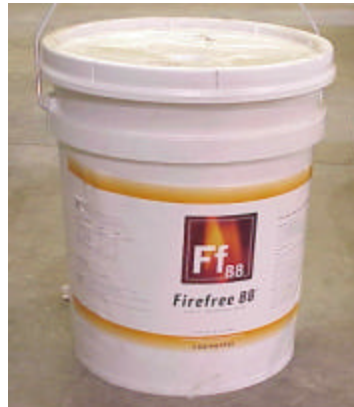
Figure 7. Firefree 88 Coating Used

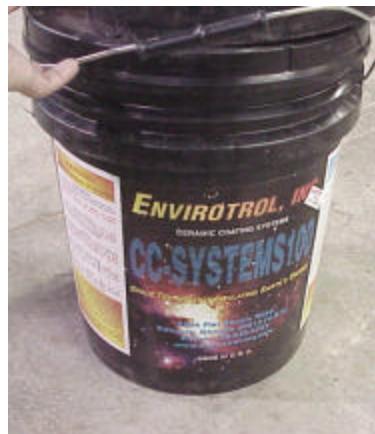
Figure 8. Envirotrol Primer Used

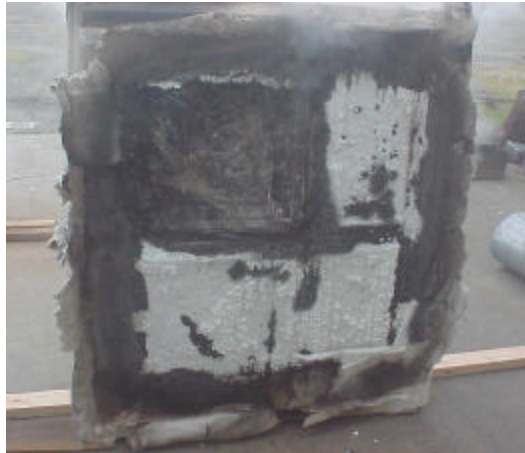
Figure 9. Post Test -- Exposed Face, Cracked Gypsum Board

51:13	More smoke leaking out from cavity.
60:00	Turn off gas, test terminated.
Post Comment	<ul style="list-style-type: none">Exposed face -- Coating stayed in position throughout the entire test. Coating foamed up approximately 1" (Figure 9).Unexposed face -- A few discoloring spots on floor finishing (Figure 10).Wood studs & oak sheathing -- Partially charred (Figure 11).

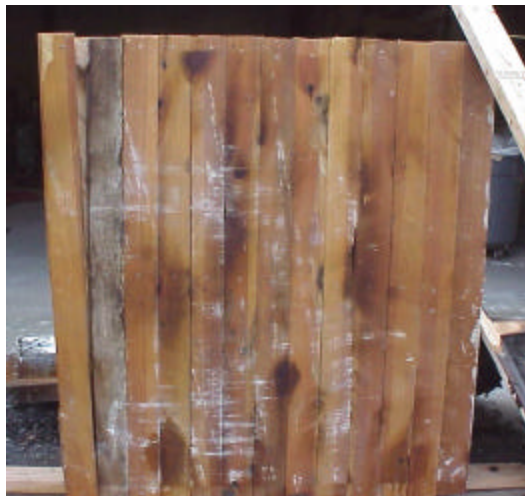
Figure 10. Post Test -- Unexposed Face Floor Finishing

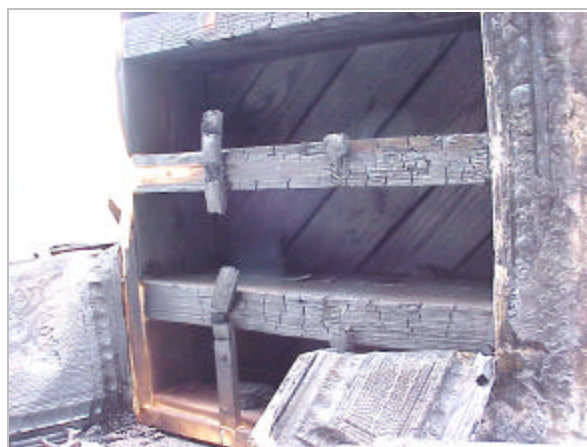
Figure 11. Post Test -- View of Cavity

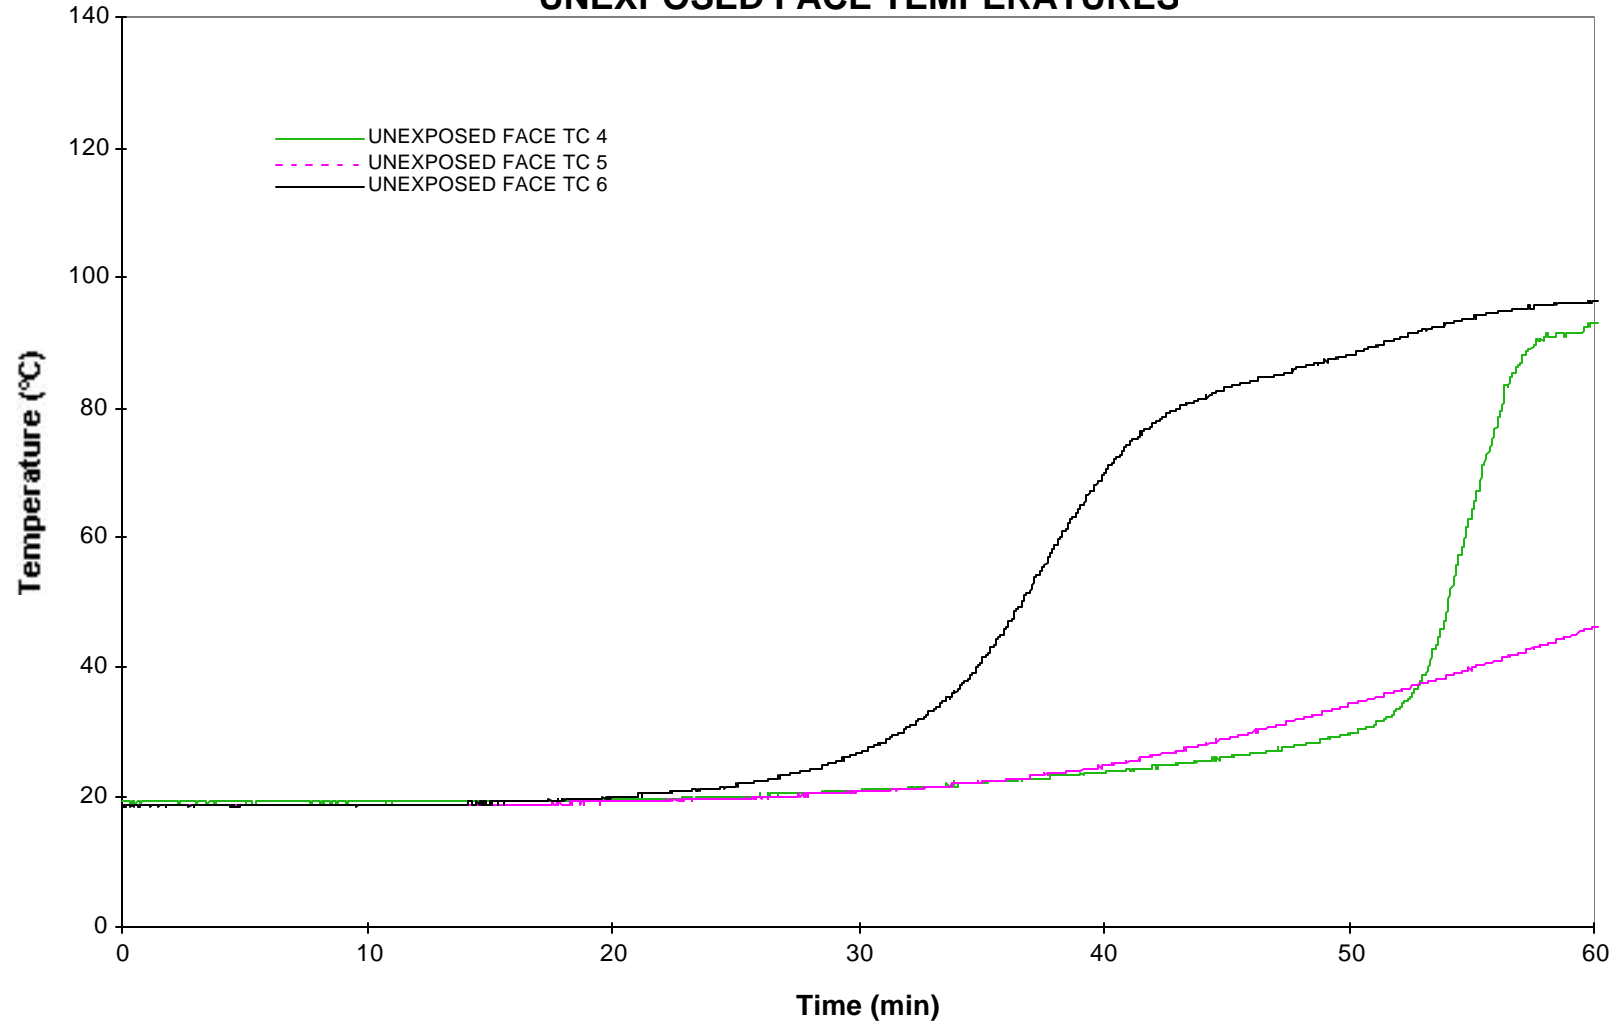
SMALL-SCALE HORIZONTAL FIRE ENDURANCE TEST 1 (10 MILS OF ENVIROTROL PRIMER, 40 DRY MILS OF FIREFREE 88 OVER EMBOSSED TIN CEILING) UNEXPOSED FACE TEMPERATURES

The temperature data was collected during the test with a computer and the results are summarized in Table 1. The charts from collected data are shown in Appendix A. The photographs from the test are also included in this report in Appendix B (Photos 1-30).

This test was terminated after 60 minutes. None of the temperature rises of the unexposed face exceeded the 121°C criteria limit. This test assembly passed the small-scale 1-hour ceiling/floor (horizontal) fire endurance test.
